# **Presence and Quality of Drinking Water Fountains in Taranaki Public Parks, Playgrounds and Major Walkways**

**Tayla Hesseltine, Bachelor of Health Sciences Intern**

**Jonathan Jarman, Public Health Physician**

**November-December 2017**

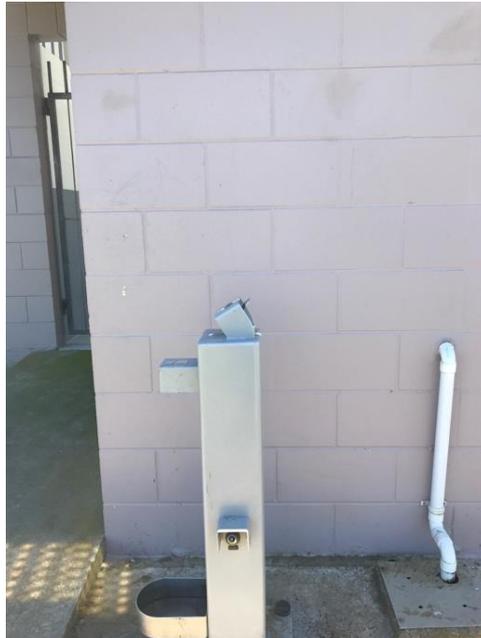
*"Soldiers Memorial Park-Eltham"*

6 out of the 17 (35%) playgrounds had a fountain with a second tap. All of the fountains with a second tap were all found in either Stratford or South Taranaki Districts.

**Photo 1: Fountain with second side tap (on left side) for filling dog drinking bowl (and tap for Council staff in front):**

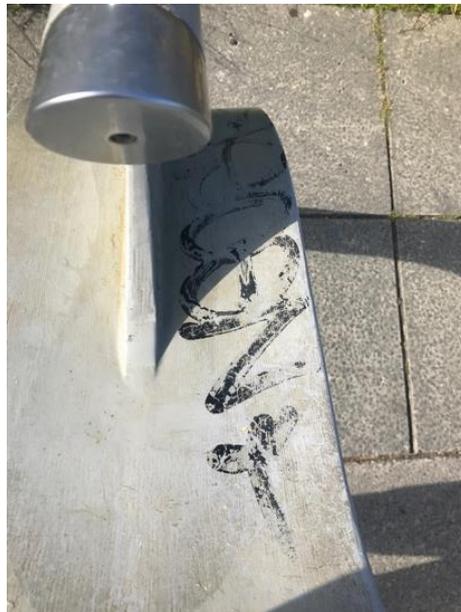
*“New Plymouth Coastal Walkway”*

2 of the 17 fountains were found to have vandalism, although it did not affect the functionality of the water fountains and they were still deemed useable and safe to drink from. Although safe to drink from they could pose psychological consequences and people may feel they are dirty or unhygienic to drink from.

**Photo 2: Vandalism**

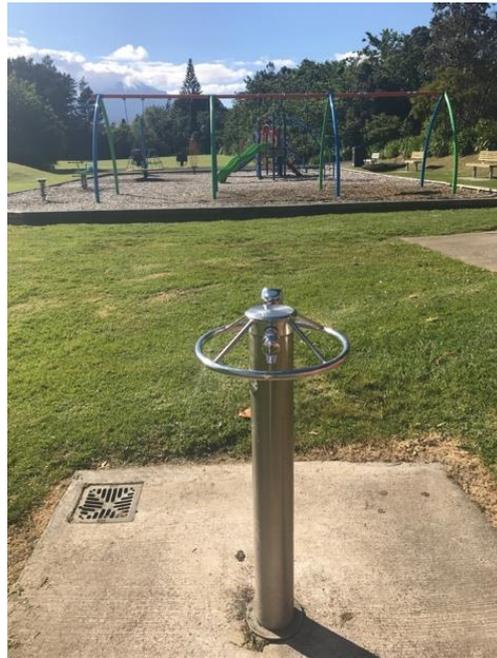
*“Okato Neighbourhood Park and Community Orchard”*

Of the 17 drinking water fountains 14 were found to be within 100m of the playground equipment making them both visible from the playground and easily accessible to those using the playground. Photo 3 is also a prime example of good quality ground surface below the drinking water fountain. It provides drainage and concrete so that the ground below is not turned to mud after continued use.

**Photo 3: Proximity to playground:**

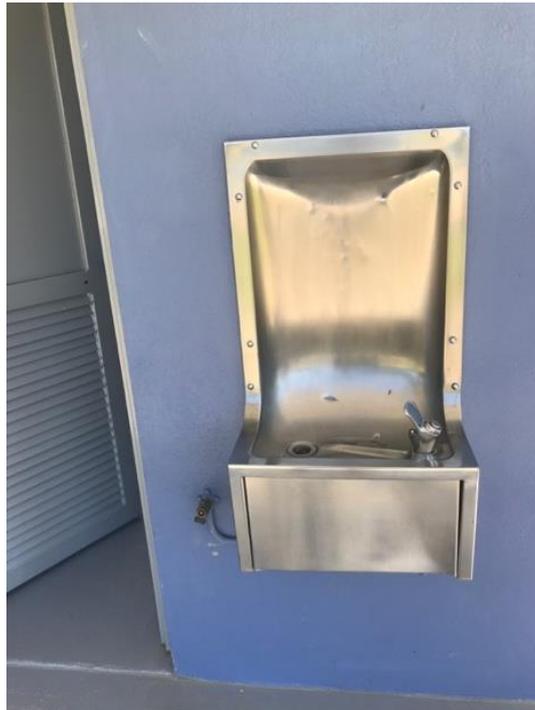
*“Hawera King Edward Park”*

Another factor that came into the analysis was the proximity to the toilet, the desired outcome was that the toilets were all at least 5m away from drinking water fountains. The data collection found that 9 of the 17 (53%) of the drinking water fountains were more than 5 metres away. 6 of the 17 playgrounds (35%) did not have a toilet and 2 of the 17 (12%) water fountains were attached to the side wall of the toilet.

**Photo 4: Fountain attached to toilet wall:**

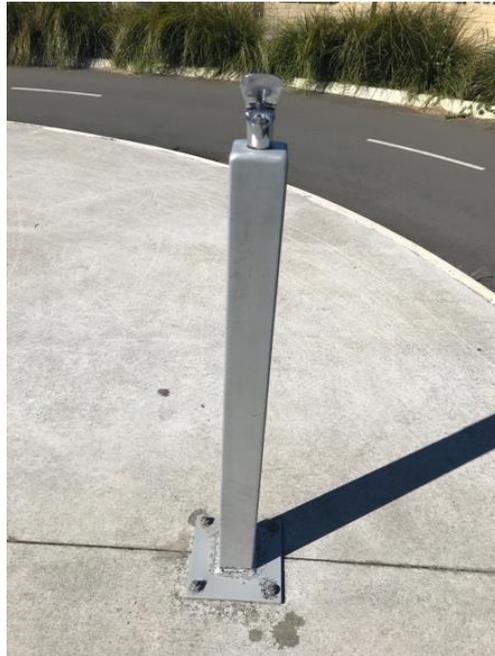
*“Taranaki Cycle Park-Bell  
Block”*

16 of the 17 drinking water fountains were measured and were all around 1 - 1.2 metres tall. This height is from the ground to the drinking nozzle. This makes the water fountains accessible to most children. Only one fountain, the historic honey field fountain on the New Plymouth Coastal Walkway was higher than 1.2 metres but it did have steps up to the nozzle to make it more accessible to everyone.

**Photo 5: Height of drinking water fountain 1.2 metres:**

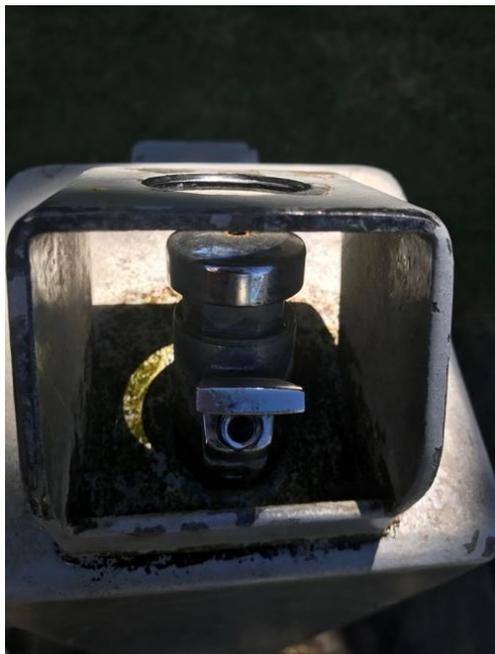
*“Hawera Skate Park”*

Cleanliness of the fountains was a major factor looked into, this was to ensure that the water was not just accessible to the public but also safe and clean to drink. Of all of the fountains surveyed 6 out of the 17 (35%) of the fountains were found to be unclean most with moss around the nozzle, making it not appealing to want to drink from. This was found to be caused by the fountains being placed in parts of the park which were shaded or covered by trees. It also appears that the fountains are not well maintained or cleaned often which is not helping with the overall uncleanliness. One was found covered in bird faeces and 2 others on the New Plymouth coastal walkway with lime scale. Most of the bottoms of the drinking water fountains were also dirty with mud, moss and lime scale, this appeared to be caused by water streaming too far out of the fountain making a muddy wet ground.

**Photo 6: Biofilm surrounding nozzle:**

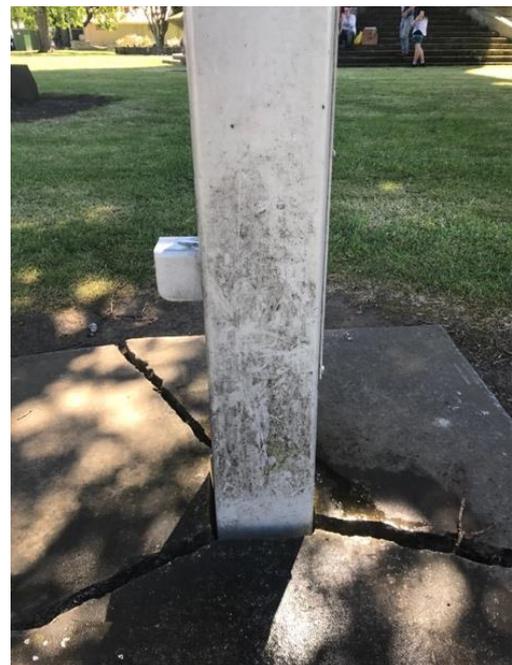
*“Hawera Skate Park”*

**Photo 7: Discolouration at bottom of fountain from possible algal growth**

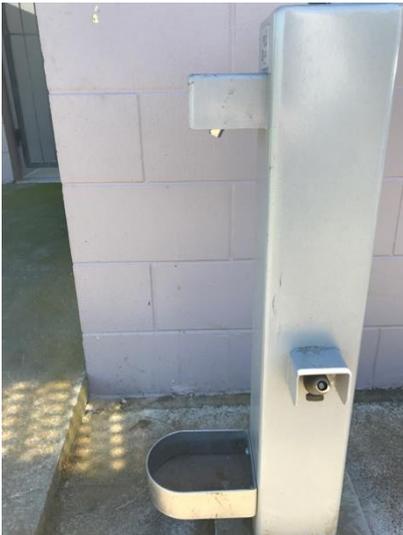
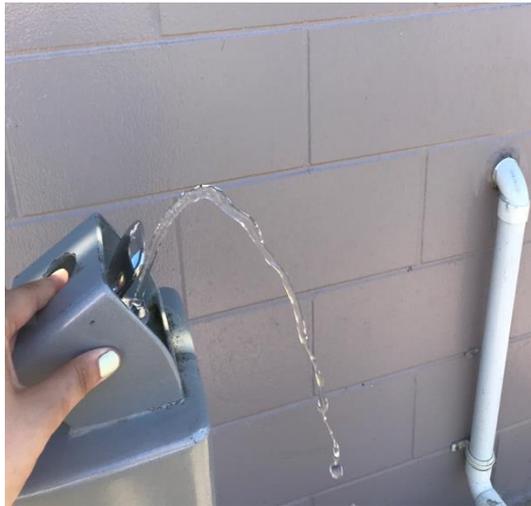
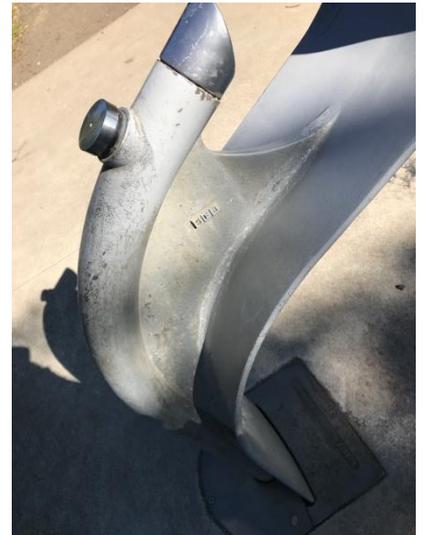
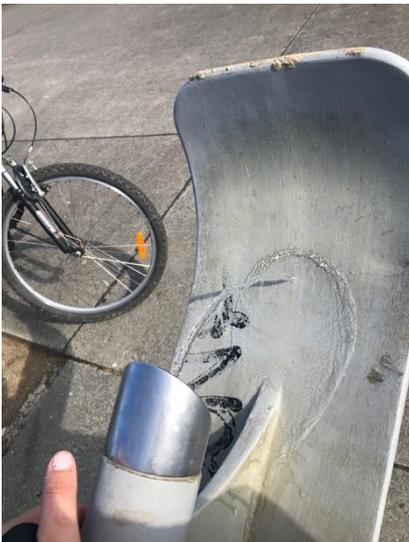
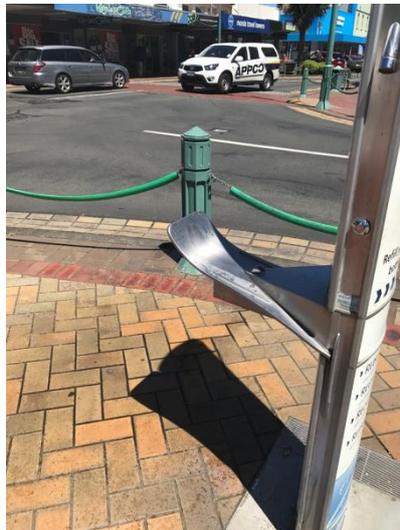
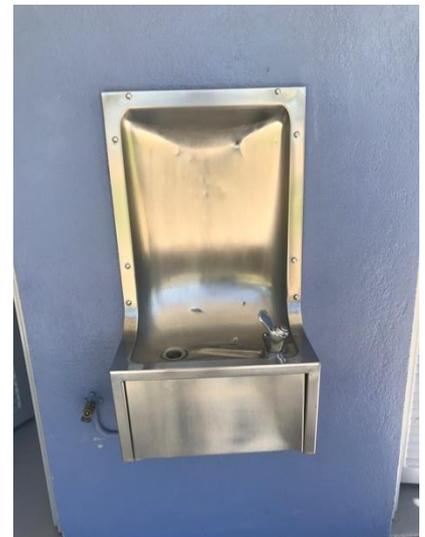
Different designs of drinking water fountains were noted. The design of the fountains was all the same in the South Taranaki and Stratford districts, these were all the fountains with a second side tap, with the exception of two fountains in Hawera. All of the fountains found in the New Plymouth region were also the same design which was a standard drinking fountain with one tap except for the Honeyfield fountain on the New Plymouth Coastal Walkway which is a historic fountain which has been preserved.
